Operational Readiness

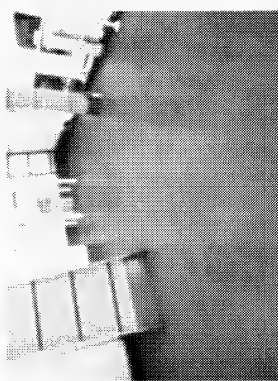
Deck 5 Wheelhouse Top		Wheelhouse Top					
Inspection Zone	Insulation	Condition	Accessibility	Friability	Recommendation	Picture	
Deckhead	n/a						
Bulkhead	n/a						
Lagging	None observed.						
Deck	Painted metal.

Other	Caulking and Penetrations present: may contain older asbestos containing materials below.						
Comments

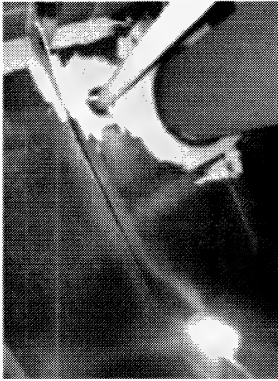
Deck 5 Wheelhouse Top		Funnel Casing				
Inspection Zone	Insulation	Condition	Accessibility	Friability	Recommendation	Picture
Deckhead	Painted metal.

Bulkhead	Perforated metal over man-made mineral fibre insulation.					
Lagging	Man-made mineral fibre insulation (Fibreglass-type) and non-asbestos textile. Cementitious elbows and fittings may contain asbestos. Navy board. High temperature jacketing and metal mesh over man-made mineral fibre insulation.				Maintain in an intact condition. Sample prior to disturbance

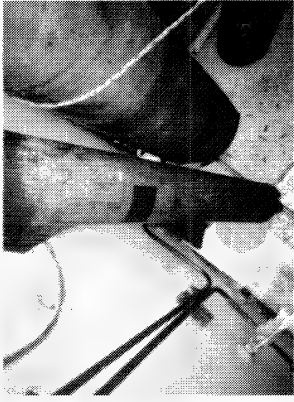
Deck	Checker plate metal catwalk.

Other	Caulking and Penetrations present: may contain older asbestos containing materials below. Possible asbestos sheet gasket material observed.

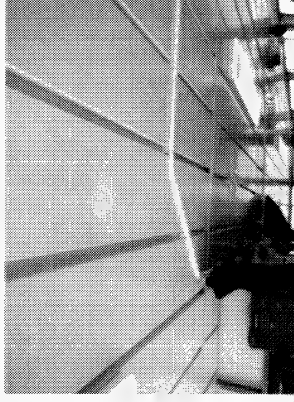
Deck 4 Navigation Bridge Deck			Wheelhouse			
Inspection Zone	Insulation	Condition	Accessibility	Friability	Recommendation	Picture
Deckhead	New non-asbestos marine panels over foil-faced man-made mineral fibre insulation.

Bulkhead	Fwd: Wood panels. Aft (behind cabinet): asbestos containing marine panel Aft center line: non-asbestos marine panel Port & Stbd: Wood panels.	FAIR	HIGH	MEDIUM	Caulk all smaller cracks and joints with fire rated caulking.

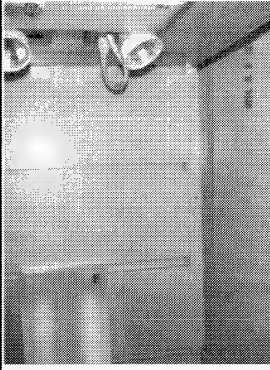
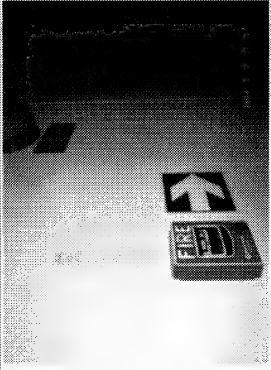
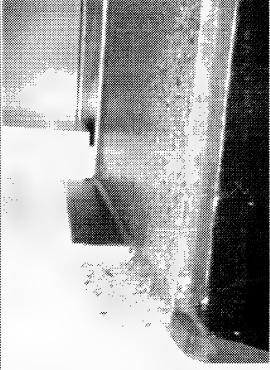
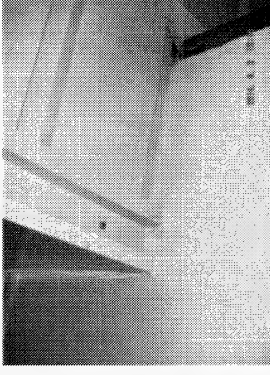
Deck 4 Navigation Bridge Deck				Stairway to Wheelhouse			
Inspection Zone	Insulation	Condition	Accessibility	Friability	Recommendation	Picture	
Deckhead	New non-asbestos marine panels over foil-faced man-made mineral fibre insulation.

Bulkhead	Asbestos containing marine panels.	FAIR - GOOD	HIGH	MEDIUM	Maintain in an intact condition. Sample prior to disturbance.

Lagging	None observed.						
Deck	Sheet flooring, possibly over asbestos containing floor tiles or deck screed Note: no info on removal of AC tiles during VLE	GOOD	LOW	LOW	Maintain in an intact condition. Sample prior to disturbance.

Comments		
	<p>2013: Some panels covered with metal sheeting. Metal flashing needs additional screw and caulking. 2014: Caulk observed on flashing. Ensure seal is maintained and repair as needed.</p>

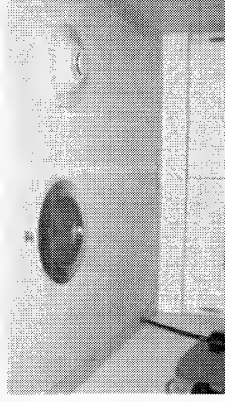
Deck 4 Navigation Bridge Deck			Library / Distress Signals			
Inspection Zone	Insulation	Condition	Accessibility	Friability	Recommendation	Picture
Deckhead	New non-asbestos marine panels over foil-faced man-made mineral fibre insulation.

Bulkhead	Asbestos containing marine panels.	GOOD	HIGH	MEDIUM	Maintain in an intact condition.

Lagging	None observed. Pipe lagging and red duct mastic above deckhead panels contains asbestos.					
Deck	New tiles possibly over asbestos containing floor tiles or deck screed Note: no info on removal of AC tiles during VLE	FAIR TO GOOD	HIGH	LOW	Remove damaged tiles under moderate risk work procedures. Maintain in an intact condition.

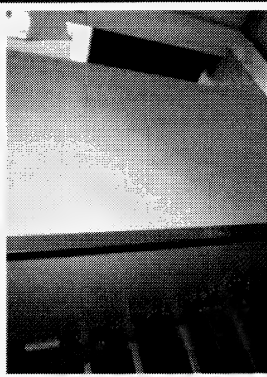
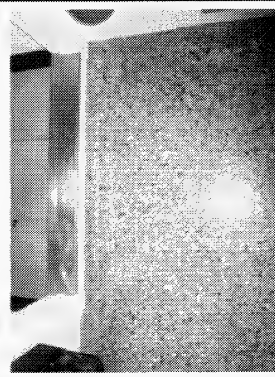
Deck 4 Navigation Bridge Deck				Alley to Communication Centre			
Inspection Zone	Insulation	Condition	Accessibility	Friability	Recommendation	Picture	
Deckhead	New non-asbestos marine panels over foil-faced man-made mineral fibre insulation.

Bulkhead	Asbestos containing marine panels.	GOOD	HIGH	MEDIUM	Maintain in an intact condition.

Lagging	None observed. Pipe lagging and red duct mastic above deckhead panels contains asbestos.

Deck	Epoxy flooring, possibly over asbestos containing floor tiles or deck screed	GOOD	LOW	LOW	Maintain in an intact condition. Sample prior to disturbance.

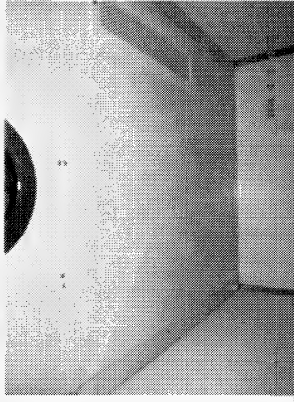
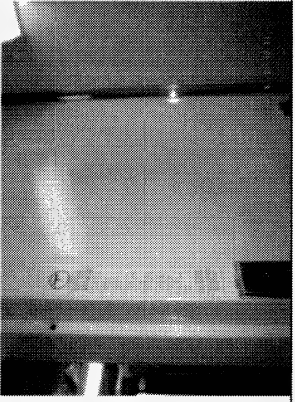
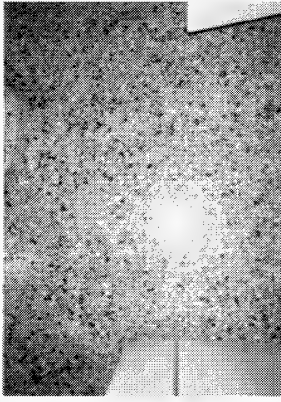
Deck 4 Navigation Bridge Deck				Washroom (N-12)			
Inspection Zone	Insulation	Condition	Accessibility	Friability	Recommendation	Picture	
Deckhead	New non-asbestos marine panels over foil-faced man-made mineral fibre insulation.

Bulkhead	Asbestos containing marine panels.	GOOD	HIGH	MEDIUM	Maintain in an intact condition.

Lagging	Pipe lagging and red duct mastic above deckhead panels contain asbestos.

Deck	Epoxy possibly over asbestos containing floor tile and deck screed.	GOOD	LOW	LOW	Maintain in an intact condition. Sample prior to disturbance.

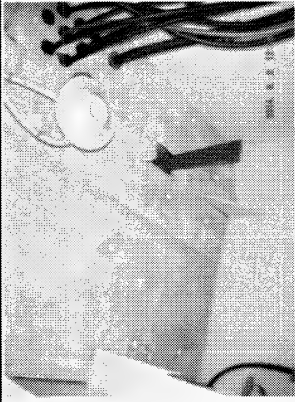
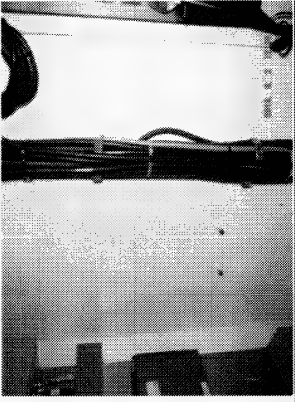
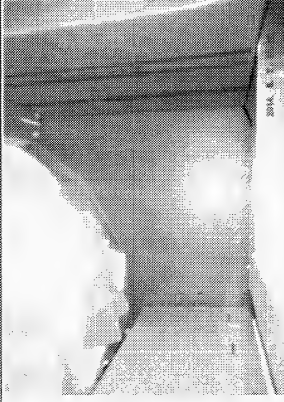
Deck 4 Navigation Bridge Deck			Communication Centre Closet			
Inspection Zone	Insulation	Condition	Accessibility	Friability	Recommendation	Picture
Deckhead	Perforated metal over man-made mineral fibre insulation.

Bulkhead	Outboard: Perforated metal over man-made mineral fibre insulation (Fibreglass-type). Rest: Painted metal.

Lagging	None observed.					
Deck	Painted metal.

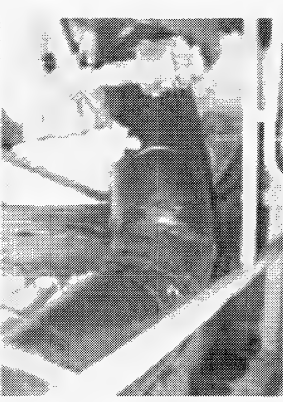
Deck 4 Navigation Bridge Deck		Spare (N-5)				
Inspection Zone	Insulation	Condition	Accessibility	Friability	Recommendation	Picture
Deckhead	New non-asbestos marine panels over foil-faced man-made mineral fibre insulation.

Lagging	Armaflex board insulation on ducts. Textile over man-made mineral fibre insulation (Fibreglass-type). Pipe lagging and red duct mastic above deckhead panels contains asbestos.

Deck	Carpet over asbestos tile and/or asbestos containing deck screed.				Maintain in an intact condition. Sample prior to disturbance.

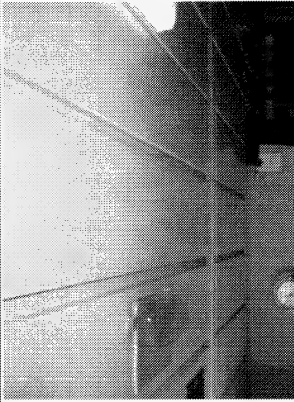
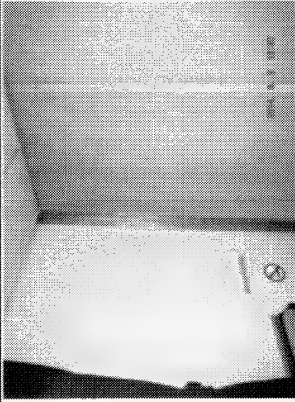
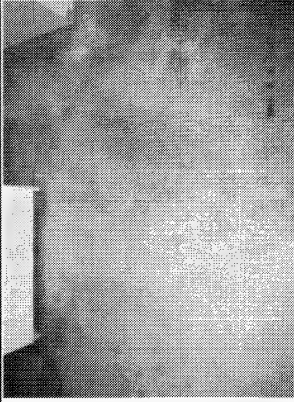
Deck 3 Boat Deck		Chief Engineer (B-6)				
Inspection Zone	Insulation	Condition	Accessibility	Friability	Recommendation	Picture
Deckhead	New non-asbestos marine panels over foil-faced man-made mineral fibre insulation.

Bulkhead	Aft: Non-asbestos marine panel. Rest: Asbestos containing marine panel.	FAIR	HIGH	MEDIUM	Maintain in an intact condition. Sample prior to disturbance.

Lagging	Pipe lagging and red duct mastic above deckhead panels contains asbestos.

Deck	Carpet over asbestos tile and/or asbestos containing deck screed.	GOOD	LOW	HIGH	Maintain in an intact condition. Sample prior to disturbance.

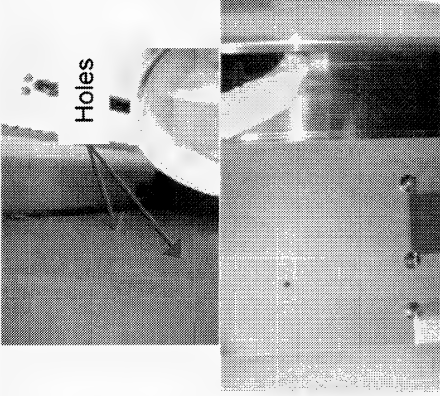
Deck 3 Boat Deck		Commanding Officer's Washroom (B01)				
Inspection Zone	Insulation	Condition	Accessibility	Friability	Recommendation	Picture
Deckhead	New non-asbestos marine panels over foil-faced man-made mineral fibre insulation.

Bulkhead	Fwd: Non-asbestos marine panel. Rest: Asbestos containing marine panels.	FAIR	HIGH	MEDIUM	Maintain in an intact condition. Sample prior to disturbance.

Lagging	None observed. Pipe lagging and red duct mastic above deckhead panels contains asbestos.

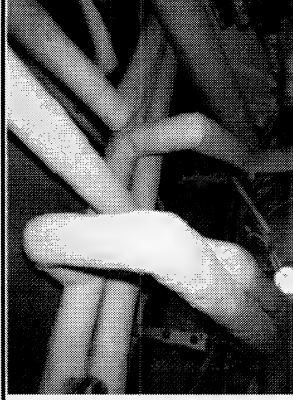
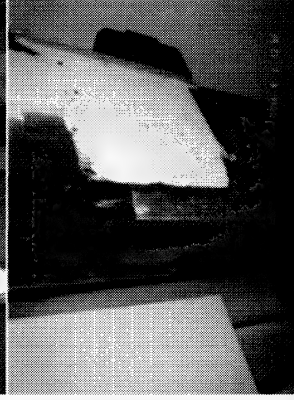
Deck 3 Boat Deck		Fan Room (B9)			
Lagging	Asbestos pipe insulation present. Armaflex insulation on ducts. Man-made mineral fibre insulation (Fibreglass-type). Red duct mastic contains asbestos.	FAIR	MEDIUM	LOW (textile)- HIGH (insulation)	Remove if possible, otherwise maintain in an intact condition.
Deck	Painted metal.				
Other	Caulking and Penetrations present: may contain older asbestos containing materials below

Deck 3 Boat Deck		Fan Room (B9)
Comments	2013: Possible original gaskets

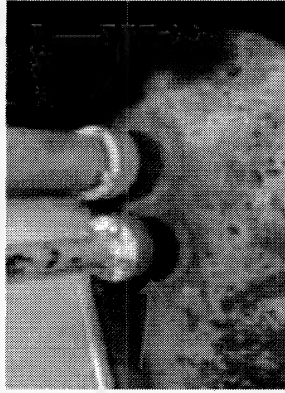
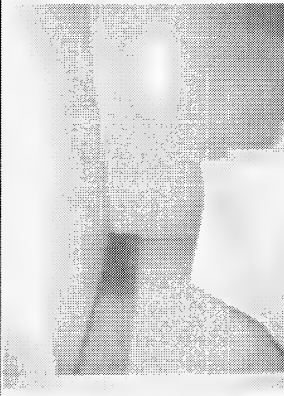
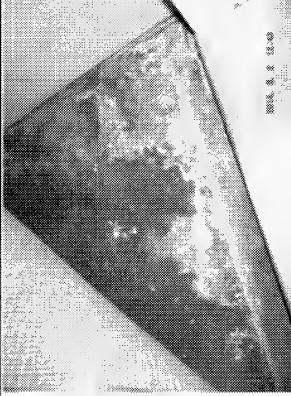
Deck 3 Boat Deck		Port Linen Locker				
Inspection Zone	Insulation	Condition	Accessibility	Friability	Recommendation	Picture
Deckhead	Wood.

Bulkhead	New non-asbestos marine panels.

Lagging	None observed.					
Deck	Metal, possibly over asbestos containing floor tile and/or deck screed.	GOOD	LOW	LOW	Maintain in an intact condition. Sample screed prior to disturbance.

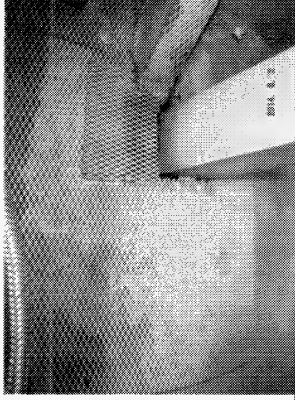
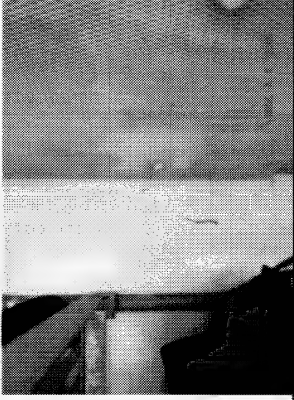
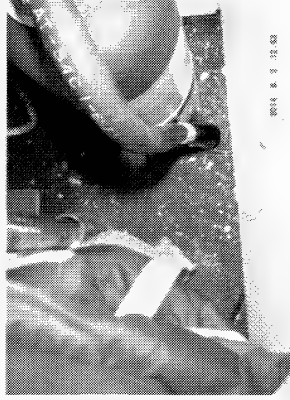
Deck 3 Boat Deck		Boat Gear Locker (B11)				
Inspection Zone	Insulation	Condition	Accessibility	Friability	Recommendation	Picture
Deckhead	Perforated metal over man-made mineral fibre insulation.

Bulkhead	Fwd and outboard: Perforated metal over man-made mineral fibre insulation. Rest: Painted metal.

Lagging	None observed.					
Deck	Painted metal.

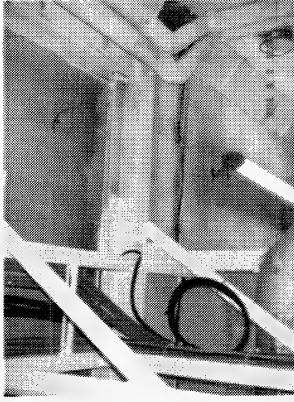
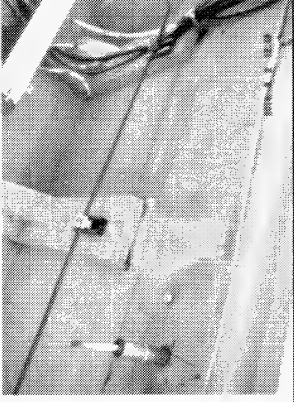
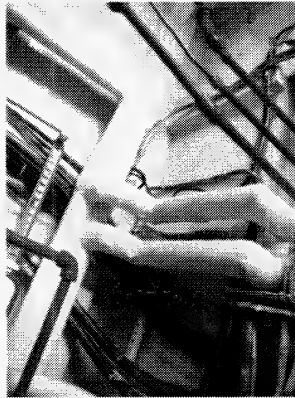
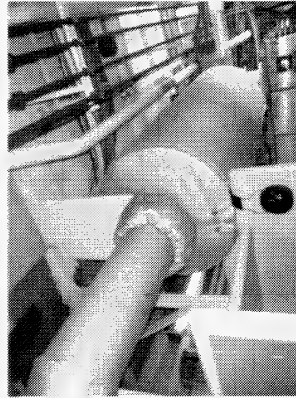
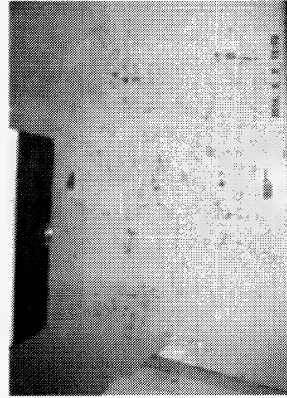
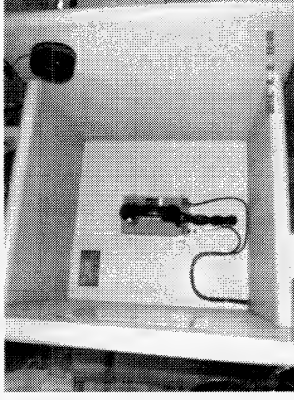
Deck 3 Boat Deck		Emergency Generator Room (B15)				
Inspection Zone	Insulation	Condition	Accessibility	Friability	Recommendation	Picture
Deckhead	Perforated metal over man-made mineral fibre insulation. Painted metal.

Bulkhead	Perforated metal over man-made mineral fibre insulation. Painted metal.

Deck 3 Boat Deck							Emergency Generator Room (B15)		
Inspection Zone	Insulation	Condition	Accessibility	Friability	Recommendation	Picture			
Lagging	<p>Pipe runs: Man-made mineral fibre insulation (Fibreglass-type).</p> <p>Pipe elbows: Cementitious elbows and fittings may contain asbestos.</p> <p>High temperature jacketing and metal mesh over man-made mineral fibre insulation.</p>				Maintain in an intact condition. Sample prior to disturbance.

Deck 3 Boat Deck		Emergency Generator Room (B15)				
Inspection Zone	Insulation	Condition	Accessibility	Friability	Recommendation	Picture
Other	<p>Caulking and Penetrations present: may contain older asbestos containing materials below.</p> <p>Acoustic phone booth may have an asbestos liner or insulation inside the casing.</p>

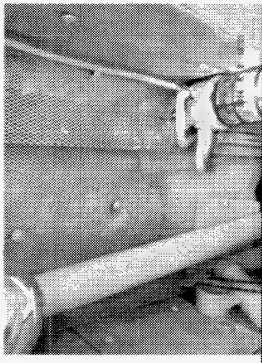
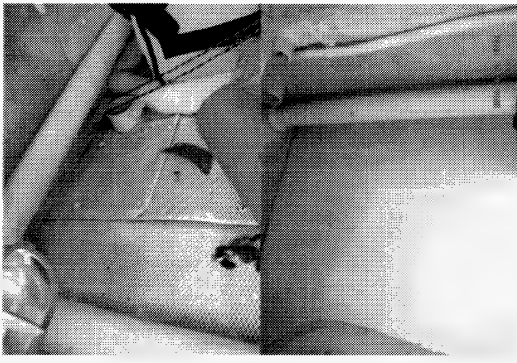
Deck 3 Boat Deck		SAR Equipment (B14)				
Inspection Zone	Insulation	Condition	Accessibility	Friability	Recommendation	Picture
Deckhead	Perforated metal over man-made mineral fibre insulation.

Bulkhead	Aft and outboard: Perforated metal over man-made mineral fibre insulation. Fwd and inboard: Painted metal.

Deck 3 Boat Deck		SAR Equipment (B14)				
Lagging	Man-made mineral fibre insulation (Fibreglass-type). insulation on pipe runs. Cementitious elbows and fittings may contain asbestos. Red duct mastic contains asbestos.

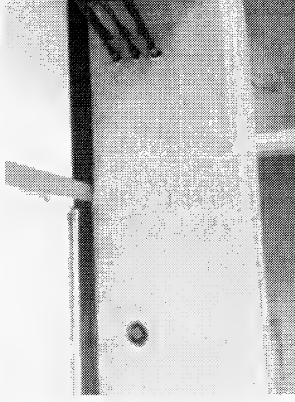
Lagging	None observed.					
Deck	Sheet flooring over possible asbestos tile and/or asbestos containing deck screed.				Maintain in an intact condition. Sample prior to disturbance.

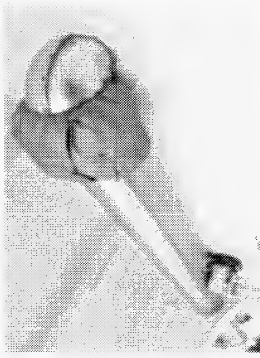
Bulkhead	Painted metal.					
Lagging	Metal over man-made mineral fibre insulation. 17oz Grey Canvas Jacketing over man-made mineral fibre insulation.				Maintain in an intact condition. Sample prior to disturbance.

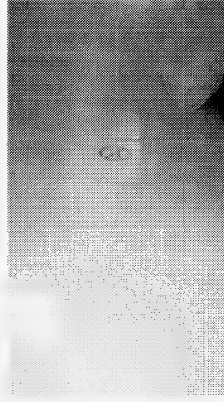
Bulkhead	Fwd and outboard: Non-asbestos marine panel. Aft and inboard: Asbestos containing marine panels. Liner under window removed during VLE 2009-10.	FAIR	HIGH	MEDIUM	Maintain in an intact condition. Sample prior to disturbance.

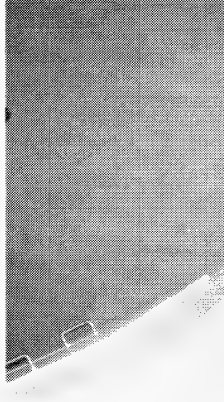
Lagging	None observed. Pipe lagging and red duct mastic above deckhead panels contains asbestos.					
Deck	Carpet over possible asbestos tile and/or asbestos containing deck screed.				Maintain in an intact condition. Sample prior to disturbance.

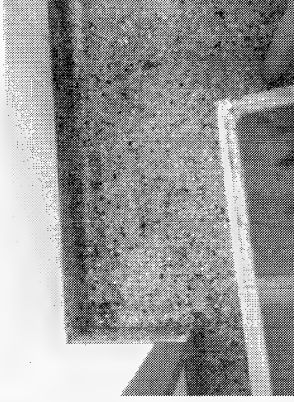
Lagging	None observed. Pipe lagging and red duct mastic above deckhead panels contains asbestos.					
Deck	Epoxy possibly over asbestos containing deck screed.				Maintain in an intact condition. Sample prior to disturbance.

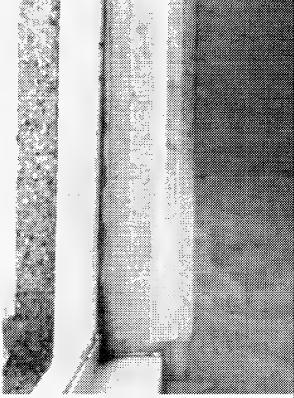
Deck	Sheet flooring over possible asbestos tile and/or asbestos containing deck screed.					Maintain in an intact condition. Sample prior to disturbance.

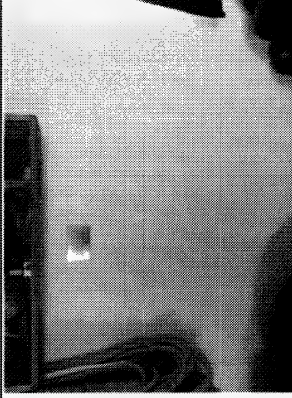
Bulkhead	Inboard: Asbestos containing marine panel. Rest: Non-asbestos marine panel.	GOOD	HIGH	MEDIUM	2013: Maintain in an intact condition. Sample prior to disturbance. 2014: Observed to be in good condition.

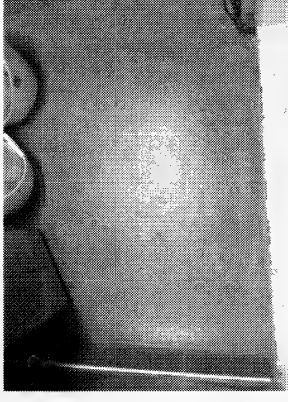
Deck	Epoxy possibly over asbestos containing deck screed.					Maintain in an intact condition. Sample prior to disturbance.

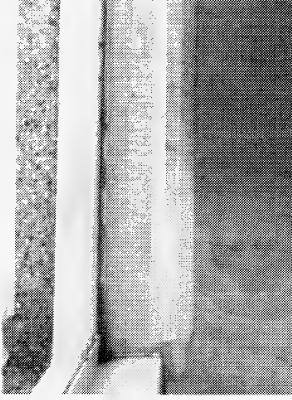
Deck	Sheet flooring over possible asbestos tile and/or deck screed (screed may contain asbestos)					Maintain in an intact condition. Sample prior to disturbance.

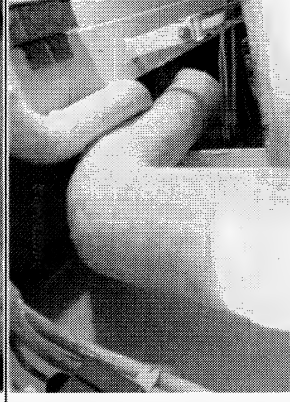
Lagging	Post refit: Man-made mineral fibre insulation (Fibreglass-type) on pipe runs. Cementitious elbows and fittings may contain asbestos.	GOOD	MEDIUM	HIGH	Maintain in an intact condition. Sample prior to disturbance.

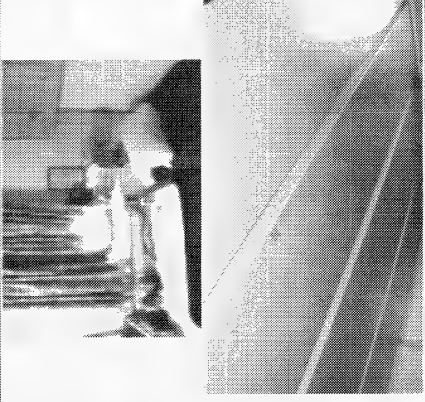
Bulkhead	Asbestos containing marine panels, except under window Note: Liner under window removed during VLE 2009-10	FAIR	HIGH	MEDIUM	Maintain in an intact condition. Sample prior to disturbance.

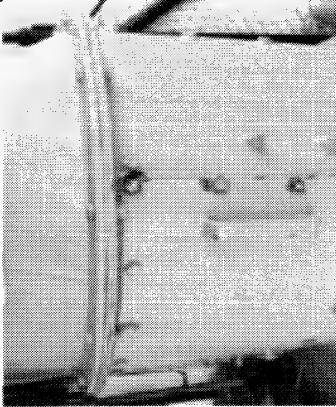
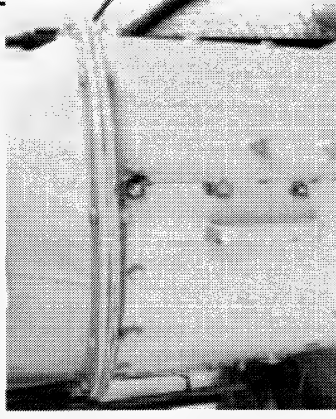
Bulkhead	N/A					
Lagging	N/A					
Deck	N/A					
Other						
Comments	Ductwork gaskets are to be handled as asbestos containing.

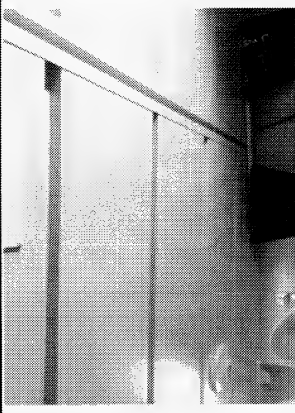
Bulkhead	Asbestos containing marine panels.	Good-Fair	HIGH	MEDIUM	Maintain in an intact condition. Sample prior to disturbance.

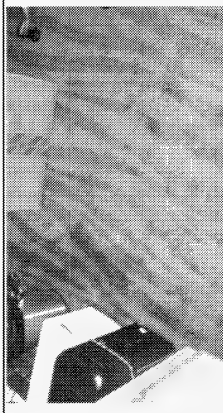
Lagging	Post refit: None observed.					
Deck	Carpet over possible asbestos tile and/or deck screed (screed may contain asbestos).				Maintain in an intact condition. Sample prior to disturbance.

Other	Caulking and Penetrations present: may contain older asbestos containing materials below.					
Comments	2013: Seal seams of asbestos marine panels.

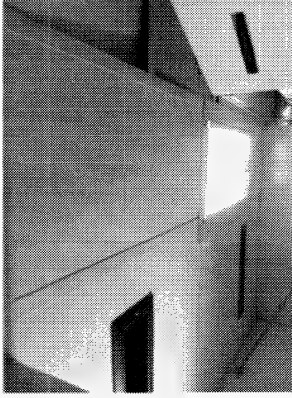
Deck 1 Upper Deck		Senior Engineer's Washroom (U-19)				
Inspection Zone	Insulation	Condition	Accessibility	Friability	Recommendation	Picture
Deckhead	New non-asbestos marine panels over foil-faced man-made mineral fibre insulation.

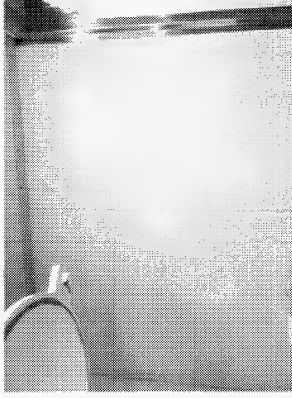
Bulkhead	Asbestos containing marine panel.

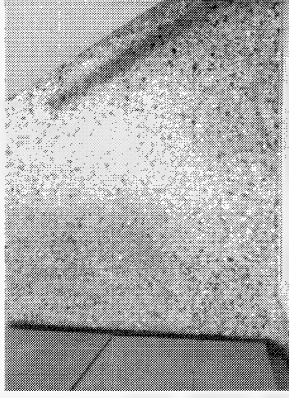
Lagging	None observed.					
Deck	Epoxy over possible asbestos containing floor tile and/or deck screed (screed may contain asbestos).				Maintain in an intact condition. Sample prior to disturbance.

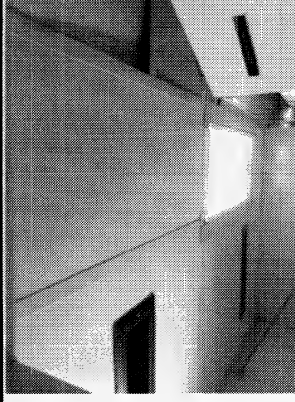
Deck 1 Upper Deck		Aft Crew's Washroom and Closet				
Inspection Zone	Insulation	Condition	Accessibility	Friability	Recommendation	Picture
Deckhead	New marine panels may be over man-made mineral fibre insulation.

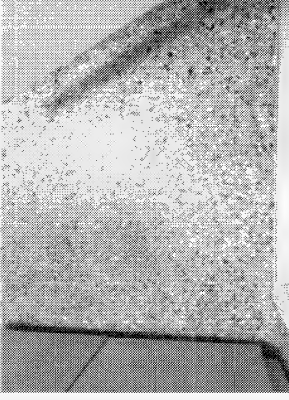
Other	Caulking and Penetrations present: may contain older asbestos containing materials below.

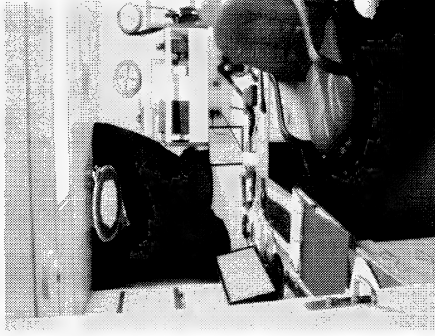
Deck 1 Upper Deck Chief Cook (U35)						
Inspection Zone	Insulation	Condition	Accessibility	Friability	Recommendation	Picture
Deckhead	New non-asbestos marine panels over foil-faced man-made mineral fibre insulation.					
Bulkhead	Asbestos containing marine panels.	FAIR	HIGH	MEDIUM	Maintain in an intact condition. Sample prior to disturbance.

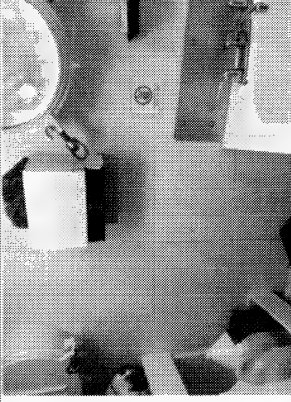
Bulkhead	Fwd and Outboard: New non-asbestos marine panels. Rest: Painted metal.	FAIR	HIGH	MEDIUM	Maintain in an intact condition. Sample prior to disturbance.

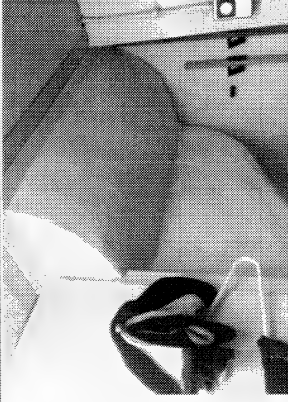
Lagging	Asbestos containing pipe insulation. Navy board insulation on ducts.	FAIR	HIGH	HIGH	Maintain in an intact condition.

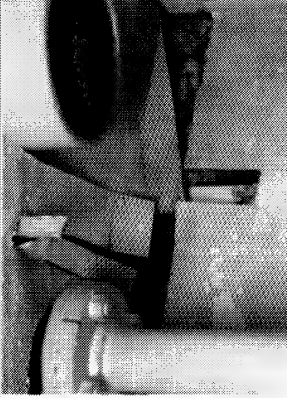
Bulkhead	Perforated metal over man-made mineral fibre insulation.

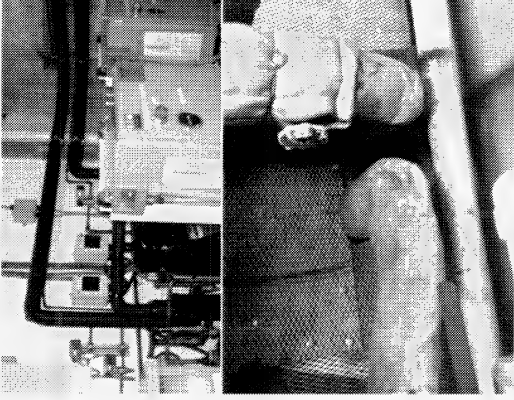
Deck 1 Upper Deck		Steering Gear Compartment				
Inspection Zone	Insulation	Condition	Accessibility	Friability	Recommendation	Picture
Lagging	<p>Armaflex insulation.</p> <p>High temperature jacketing and metal mesh over man-made mineral fibre insulation.</p>	GOOD	MEDIUM	MEDIUM	Maintain in an intact condition.

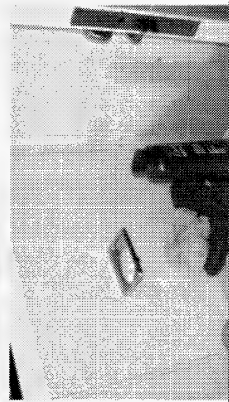
Bulkhead	New non-asbestos marine panels. Asbestos containing marine panels.	POOR TO FAIR	HIGH		Maintain in an intact condition. Sample prior to disturbance.

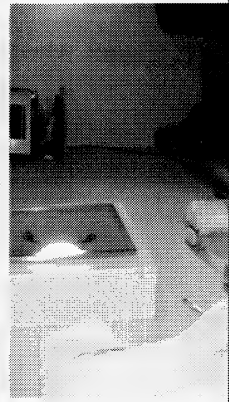
Bulkhead	Rest: New non-asbestos marine panels. Inboard: Asbestos containing marine panel.	FAIR	HIGH	MEDIUM	Maintain in an intact condition. Sample prior to disturbance.

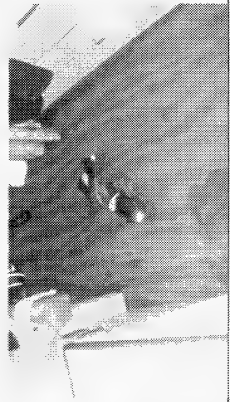
Lagging	None observed. Pipe lagging and red duct mastic above deckhead panels contains asbestos.					
Deck	Carpet over possible asbestos tile and/or deck screed (screed may contain asbestos). VLE 2009-2010: Removal of deck steel plate from outboard bulk head to approximately 6' inboard. Unable to verify extent	GOOD	LOW	LOW	Maintain in an intact condition. Sample prior to disturbance.

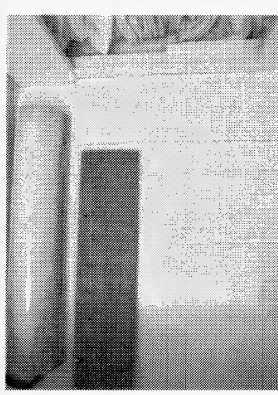
Bulkhead		Asbestos containing marine panel.	FAIR	HIGH	MEDIUM	Repair damaged marine panels with sheet metal flashing or equivalent. Caulk all smaller cracks and joints with fire rated caulking.

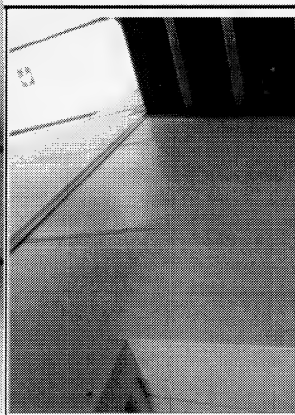
Bulkhead	New non-asbestos marine panels.

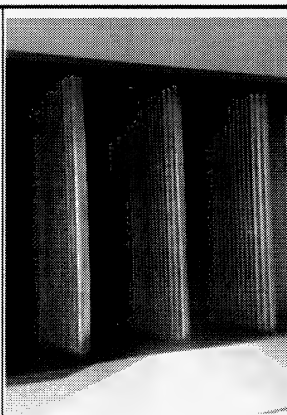
Lagging	None observed. Pipe lagging and red duct mastic above deckhead panels contains asbestos.						
Deck	Sheet flooring over possible asbestos tile and/or deck screed (screed may contain asbestos).	GOOD	LOW	LOW	Maintain in an intact condition. Sample prior to disturbance.

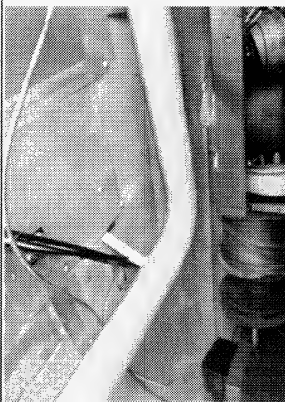
Lagging	Possible parged pipe elbows exist which may contain asbestos.

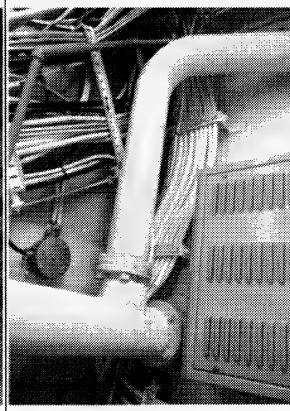
Lagging	Possible padded pipe elbows exist which may contain asbestos.

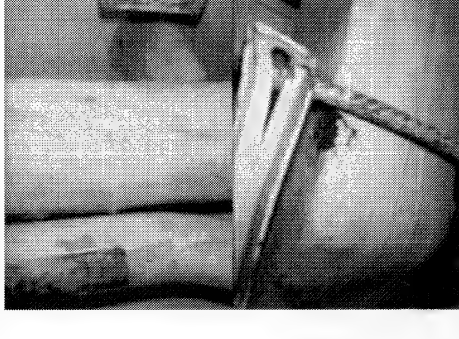
Painted metal.	No suspect asbestos.	N/A	N/A	N/A	N/A	
Lagging	Pipe insulation.	Pipe lagging suspected of containing asbestos based on sample results: • collected by PHH • collected by PEC	Good	Friable	A	7

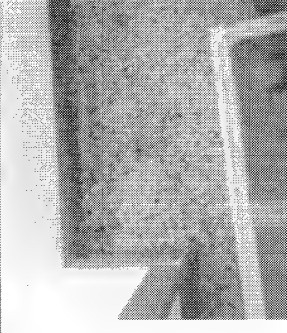
Deck 2 Poop Deck					Galley (P16)		
Inspection Zone	Material	Asbestos Content	Condition	Friability	Accessibility	Recommended Action	Photograph
		Deck screed contains asbestos based on sample results: <ul style="list-style-type: none"> 16579-1 to 3 Deck screed and brown insulation (NWest) collected by PEC 	Unknown	Non-friable	D	7

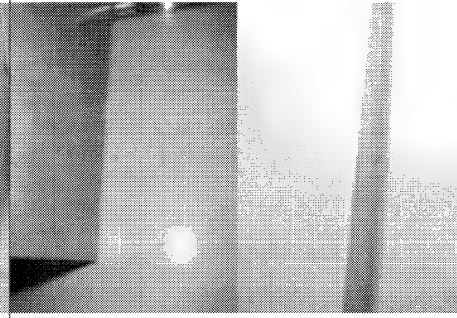
Bulkhead	Asbestos containing marine panels (except under window)	Marine panels contain asbestos based on sample results: • collected by PEC	Good	Non-friable	A	7

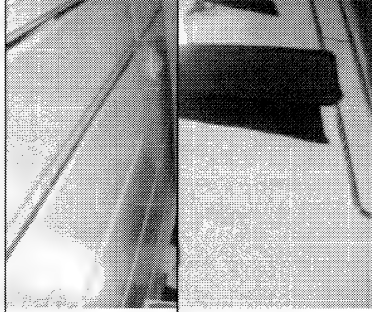
Bulkhead	Non-asbestos marine panels over foil-faced fibrous insulation.	No suspect asbestos.	N/A	N/A	N/A	N/A	
Lagging	Pipe lagging.	Pipe lagging contains asbestos based on sample results: • collected by PHH • collected by PEC	Good	Friable	C (concealed)	7	
	Red duct mastic.	Red duct mastic contains asbestos based on sample results: • collected by PEC	Good	Non-friable	C (concealed)	7	
Deck	Epoxy over Deck screed and Thermobestos block insulation	Epoxy may contain asbestos. Deck screed contains asbestos based on sample results:	Good	Non-friable	A	7	
			Debris (if exposed)	Non-friable	D	7

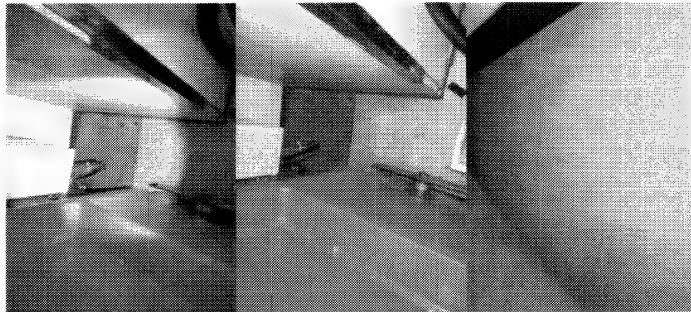
Deck 1 Upper Deck					Starboard Alleyway		
Inspection Zone	Material	Asbestos Content	Condition	Friability	Accessibility	Recommended Action	Photograph
Deck	Resilient sheet flooring over asbestos tile and/or deck screed and thermobestos block insulation.	Resilient sheet flooring – no suspect asbestos	N/A	N/A	N/A	N/A

Deck screed contains asbestos based on sample results: <ul style="list-style-type: none">16579-1 to 3 Deck screed and brown insulation (NWest)collected by PEC	Unknown	Non-friable	D	7	
		Floor tiles, if present, presumed to contain asbestos based on sample results: <ul style="list-style-type: none">32927-1 Floor Tile (Tan) NWestCollected by PEC	Unknown (concealed)	Non-friable	D	7	
		Thermobestos block insulation contains asbestos based on sample results: collected by NWest (16579-3).	Debris (if exposed)	Friable	D	Action 7 Monitor in place with routine surveillance	
Comments	N/A

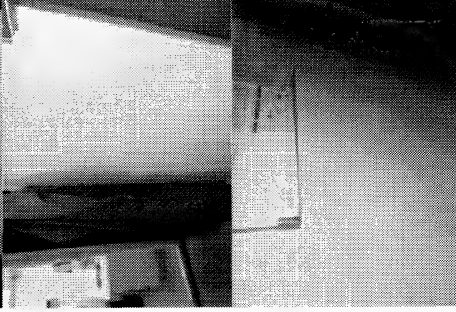
Bulkhead	Asbestos Marinite panels.	Marinite panels contain asbestos based on sample results: • collected by PHH	Good	Non-friable	A	7

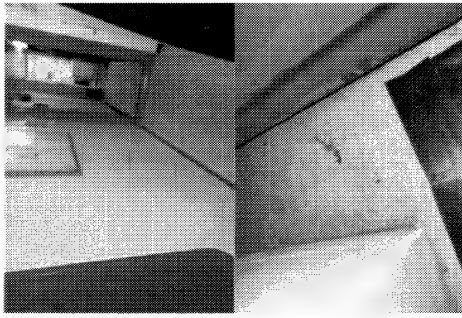
Deck screed contains asbestos based on sample results: • 16579-1 to 3 Deck screed and brown insulation (NWWest) • collected by PEC	Unknown	Non-friable	D	7	
		Floor tiles, if present, presumed to contain asbestos	Unknown (concealed)	Non-friable	D	7

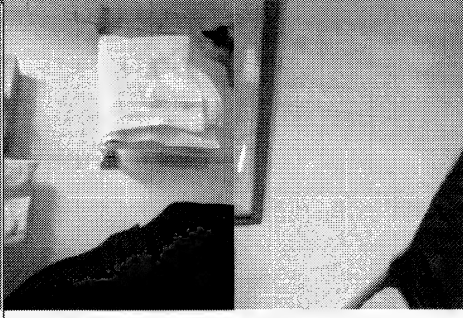
Lagging	Pipe lagging.	Pipe lagging contains asbestos based on sample results: • collected by PHH • collected by PEC	Good	Friable	C (concealed)	7

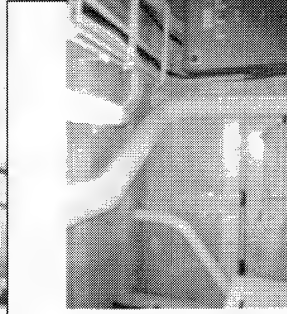
Pipe lagging	Pipe lagging contains asbestos based on sample results: • collected by PHH • collected by PEC	Good-Fair	Friable	A	Good: 7Fair: 5/6	
Lagging	Textile wrap over fibrous insulation (Fibreglass-type).	No suspect asbestos.	N/A	N/A	N/A	N/A

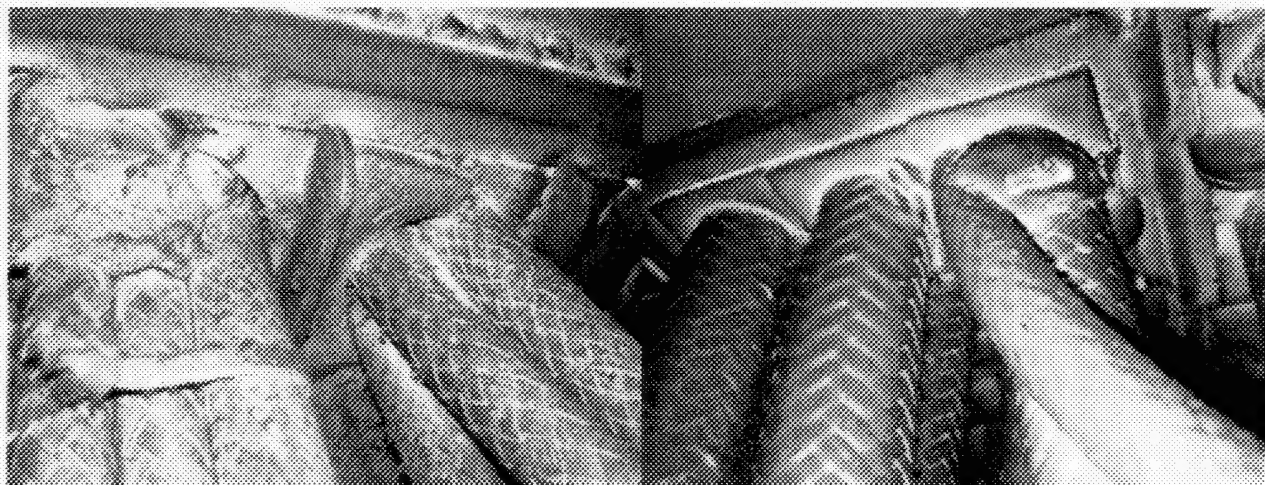
I figured that I would send a few pictures of the transits to show the current state they are in. Of the five transits in that area four of them have multiple cables through single transit blocks as shown. There are also gaps around other cables due to the wrong size blocks being used such as a row of 3 x 30mm blocks and one 20mm block in the same row. If there is any loose asbestos laying on top of these it would fall on us while working from below and also contaminate the space below so before they are disturbed the clean up is required. As Ross has stated the refit has just started so there is time to deal with these properly.

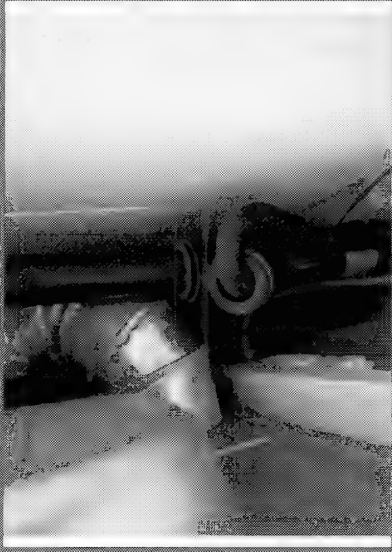
<p>Unit/Location: Laundry Room</p> <p>Description: Dust behind washers and dryers to be cleaned.</p> <p>Comments: Remove units and clean backsides of units and the bulkhead and deck.</p>

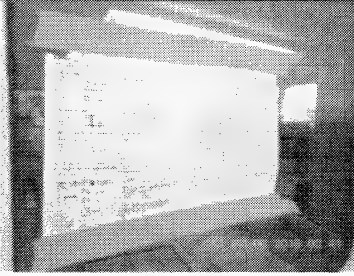
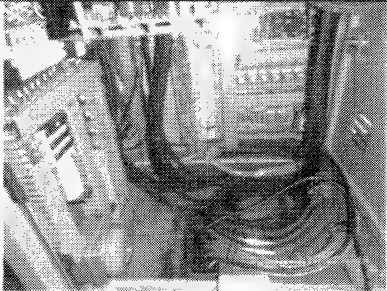
Photo of NOPA posted on work site.	Example of dust cleaned from a console.

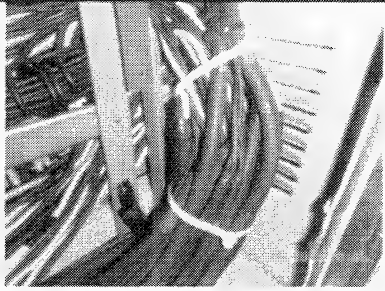
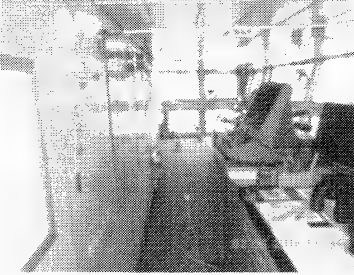
Example of dust removed from a console.	Example of cleaned surfaces in the Wheelhouse

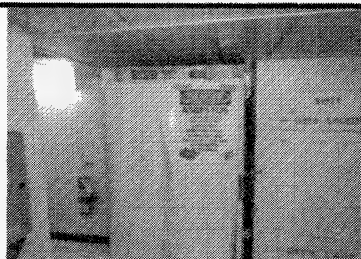
Photo of entrance into the Landry Room. Popup enclosure was used to create a larger work space.

Remove asbestos-containing dust from all surfaces behind the washing machines and dryers. Clean all exposed surfaces in the laundry room. Moderate risk clean up of less than 5 square meters of dusty surfaces.

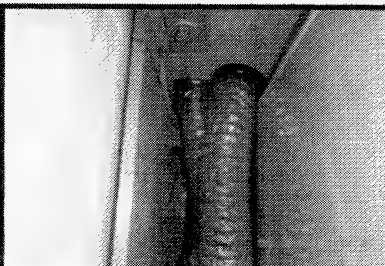
Example of dust cleaned from behind units.

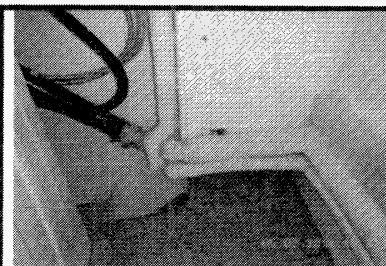
Example of dust removed from the work area.

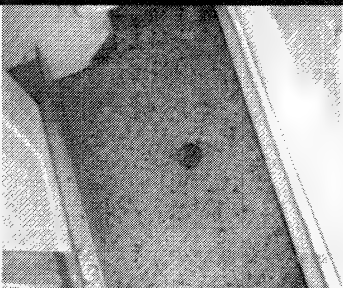
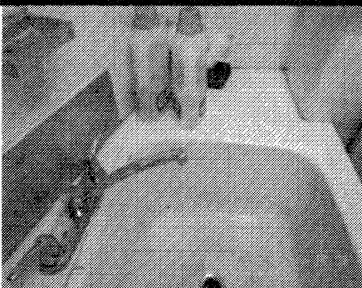
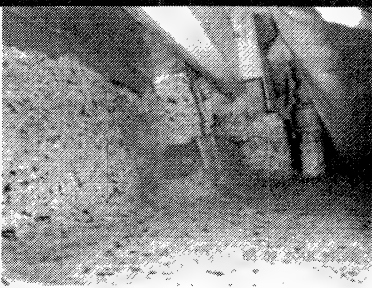
Example of dust removed from the work area.	Example of Laundry Room exposed surface cleaned of dust.	Example of the deck beneath the units cleaned of dust.
Notice of Project — Asbestos	NOPA E768383	
Waste manifest documentation	BP16288-2	
Consultant that performed the final visual inspection	Brian Salmon, Technologist	
<p>This space was originally cleaned following the discovery of a crack in the asbestos-containing bulkhead panel under the porthole. The abatement contractor cleaned all accessible surfaces, including inside cupboards following moderate risk procedures. Dust was observed behind the washers and driers, which are fastened into place, rendering this dust inaccessible. NWest conducted surface wipe sampling and found the dust to contain asbestos, warranting additional efforts to remove it.</p> <p>NWest conducted a Final Visual Inspection and clearance air sampling. The work appeared to have been conducted in accordance with regulatory requirements for asbestos abatement and in accordance with report "34699 RA1 V1.0 - CCGS Bartlett Dust Abatement".</p>

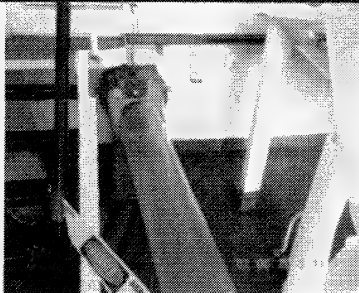
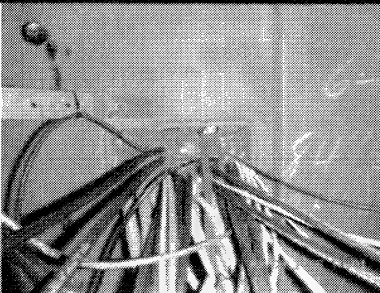
Negative air unit venting to exterior of ship.	Example of dust cleaned from the surface of cables.

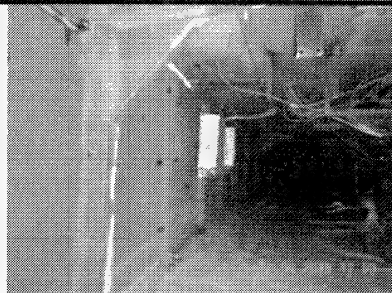
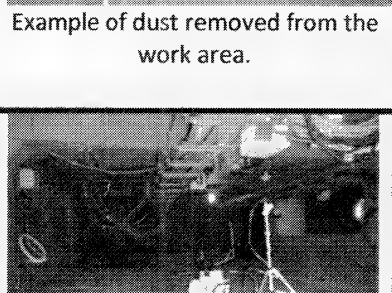
Example of dust removed from the work area.	Example of dust removed from the work area.

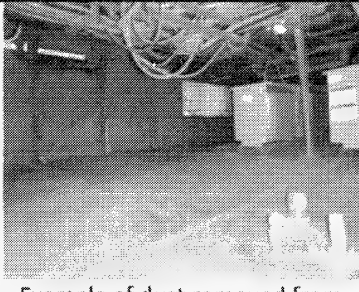
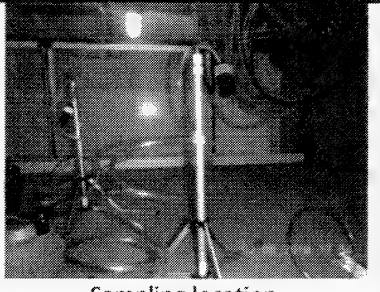
Example of dust removed from the work area. Exposed fibrous insulation removed.	Sampling location.

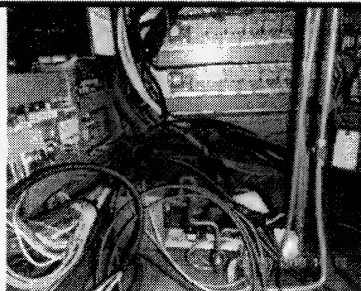
MCR: Accessible surfaces in console cleaned.

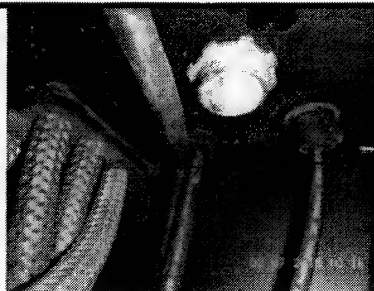
MCR: Example of conduit opening. Asbestos-containing cables removed and the conduit opening sealed.

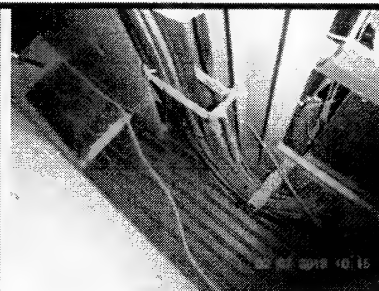
MCR: Deck and first foot of cables behind the console were cleaned.

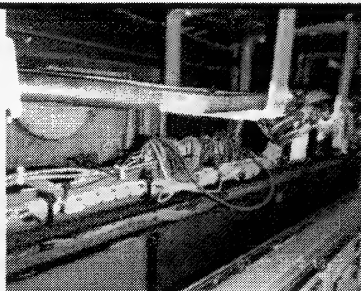
MCR: Accessible surfaces in backside of console cleaned.

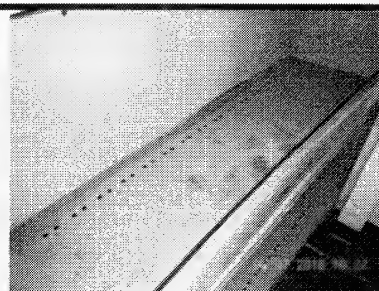
MCR Stores: Asbestos-containing materials removed and shelving cleaned.

Bulk sample of stored gaskets identified asbestos-containing rope gasket/packing materials. The asbestos-containing gaskets have been exposed in the MCR Stores for an unknown length of time. This warranted efforts to remove all dust and debris from MCR Stores and MCR Console area.

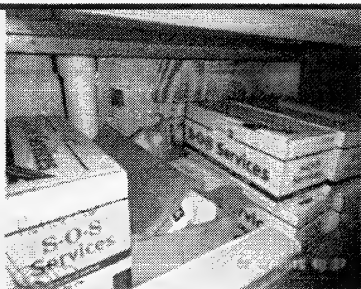
MCR Stores: Boxes and other materials to remain were vacuumed.

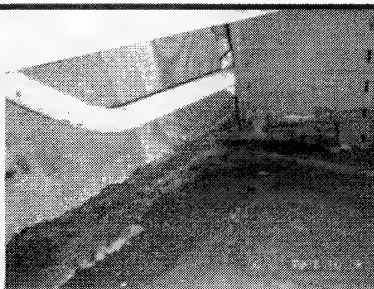
MCR Stores: Deck beneath shelving cleaned.

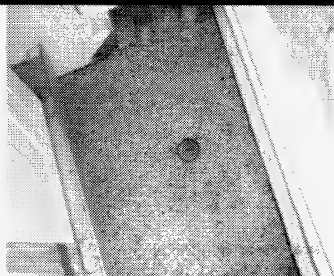
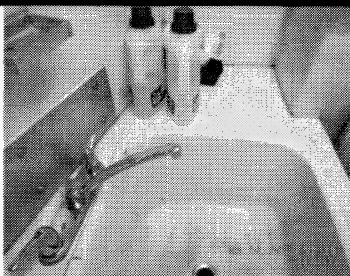
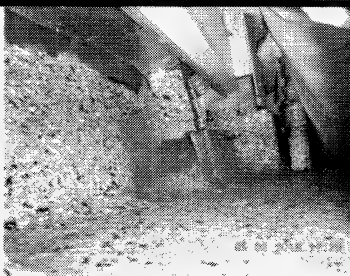
Example of dust removed from the work area.	Example of Laundry Room exposed surface cleaned of dust.	Example of the deck beneath the units cleaned of dust.
Notice of Project — Asbestos	NOPA E768383	
Waste manifest documentation	BP16288-2	
Consultant that performed the final visual inspection	[Redacted] Technologist	
<p>This space was originally cleaned following the discovery of a crack in the asbestos-containing bulkhead panel under the porthole. The abatement contractor cleaned all accessible surfaces, including inside cupboards following moderate risk procedures. Dust was observed behind the washers and driers, which are fastened into place, rendering this dust inaccessible. NWest conducted surface wipe sampling and found the dust to contain asbestos, warranting additional efforts to remove it.</p> <p>NWest conducted a Final Visual Inspection and clearance air sampling. The work appeared to have been conducted in accordance with regulatory requirements for asbestos abatement and in accordance with report "34699 RA1 V1.0 - CCGS Bartlett Dust Abatement".</p>

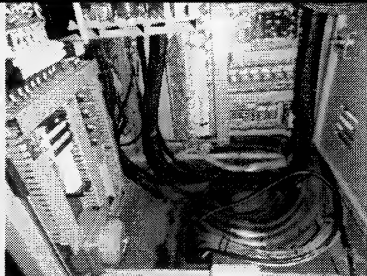
Photo of NOPA posted on work site.	Example of dust cleaned from a console.

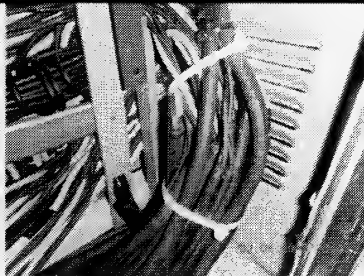
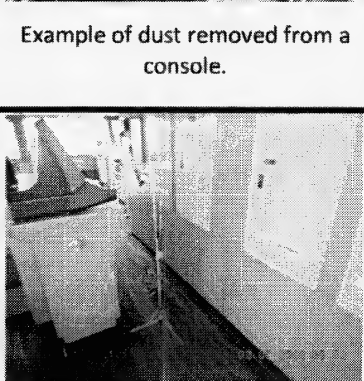
Example of dust removed from a console.

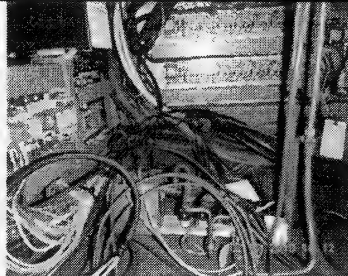
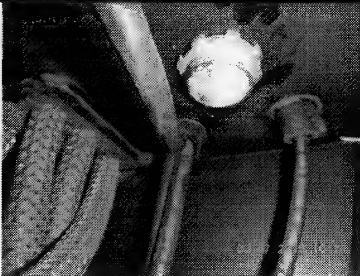
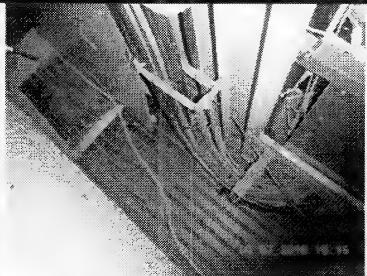
MCR: Accessible surfaces in console cleaned.	MCR: Example of conduit opening. Asbestos-containing cables removed and the conduit opening sealed.	MCR: Deck and first foot of cables behind the console were cleaned.

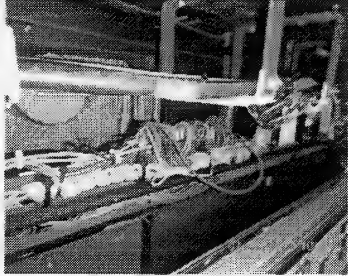
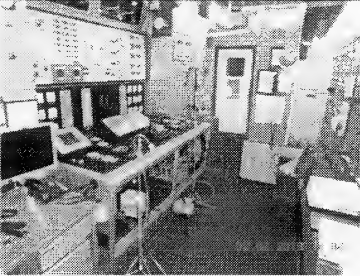
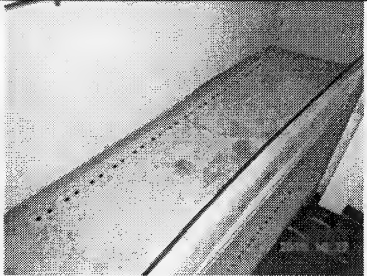
MCR: Accessible surfaces in backside of console cleaned.	MCR: Air clearance samples.	MCR Stores: Asbestos-containing materials removed and shelving cleaned.

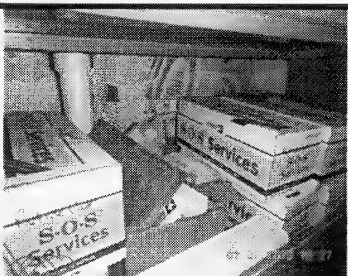
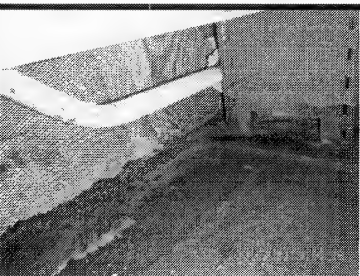
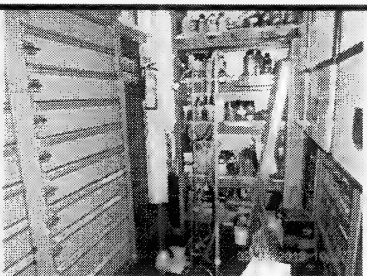
MCR Stores: Boxes and other materials to remain were vacuumed.	MCR Stores: Deck beneath shelving cleaned.	MCR Stores: Air clearance samples.
Notice of Project — Asbestos	NOPA E768383	
Waste manifest documentation	BP16288-2	
Consultant that performed the final visual inspection	Technologist

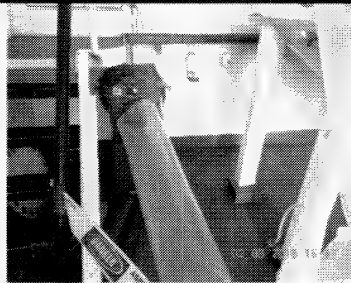
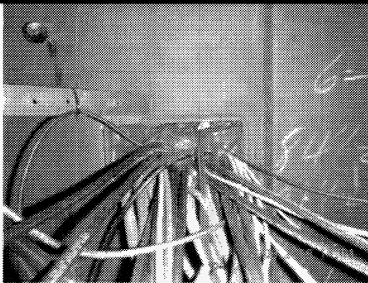
Negative air unit venting to exterior of ship.	Example of dust cleaned from the surface of cables.

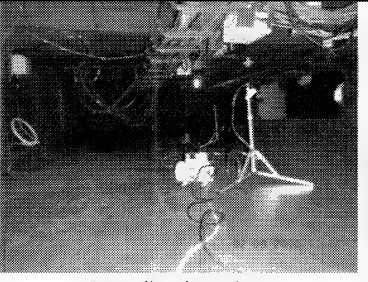
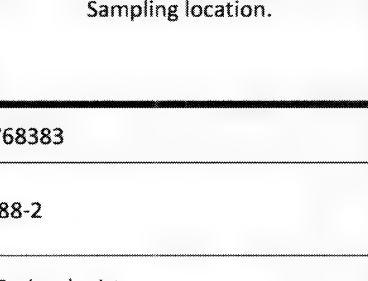
Example of dust removed from the work area. Exposed fibrous insulation removed.	Sampling location.

Sampling location.	Sampling location.
Notice of Project — Asbestos	NOPA E768383
Waste manifest documentation	BP16288-2
Consultant that performed the final visual inspection	Technologist
<p>The presence of asbestos containing cables and dust was found in the Wheelhouse consoles. Some consoles have unsealed penetrations into the Void space, effectively sharing the same air space. Asbestos-containing cables may be present in the Void space.</p> <p>NWest conducted occupational sampling, a final clearance inspection, and final visual inspection. The work was conducted in accordance with regulatory requirements for asbestos abatement and in accordance with report "34699 RA1 V1.0 - CCGS Bartlett Dust Abatement".</p>

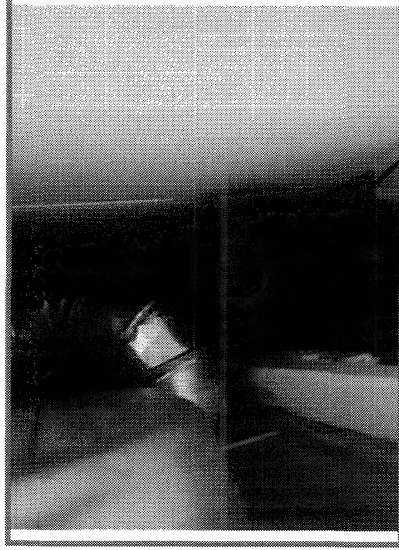
<p>Unit/Location: Laundry Room</p> <p>Description: Dust behind washers and dryers to be cleaned.</p> <p>Comments: Remove units and clean back sides of units and the bulkhead and deck.</p>
